## Stereo AV / IR Pass-Thru Balun 500048, 500049 Quick Installation Guide

The Stereo AV/IR Pass-Thru Balun (500048, 500049) allows one (1) composite video, one (1) stereo audio and one (1) IR emitter signal to be transmitted via a single Cat 5E/6 cable in a point-to-point connection. The Stereo AV/IR Pass-Thru Balun features full audio bandwidth response for high fidelity applications and features built-in color-coded cable leads for ease of installation. The Stereo AV/IR Pass-Thru Balun also works in conjunction with third party IR Remote Control equipment. This enables the IR Emitter to connect to the IR control module using the same Cat 5E/6 cable as video and audio, allowing for more cost-efficient cabling. Some applications include: Classroom video distribution, commercial and home audio/video systems, hospital video training, video conferencing, and video kiosks

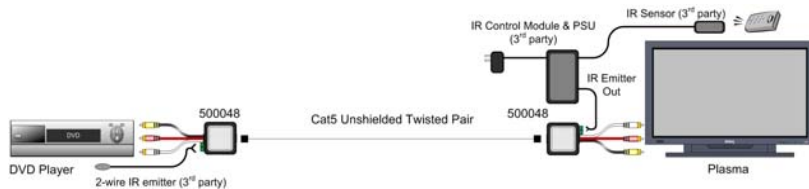
3. Plug the second balun into the composite video/stereo audio input of the video screen or receiver at the remote end.
4. Complete the connection between the two baluns, using standard Cat 5E/6 twisted pair cable and connecting hardware, terminated on RJ45 plugs at both ends. Ensure that there are no split pairs or taps.
5. Power-on the audio-video equipment. Check the image quality and refer to the troubleshooting table below if the image quality is unsatisfactory. The following diagram shows a typical installation.

One (1) pair of baluns is needed to complete one composite stereo audio-video connection via Cat 5E/6 twisted pair. To install the baluns, perform the following steps:

2. Plug one (1) balun into the composite video/stereo audio output of the video source according to the color code of the RCA cable leads.
